**MARLBOROUGH  
DISTRICT COUNCIL**

# Recreational Water Quality Report 2018-2019

**Technical Report No: 19-003  
May 2019**

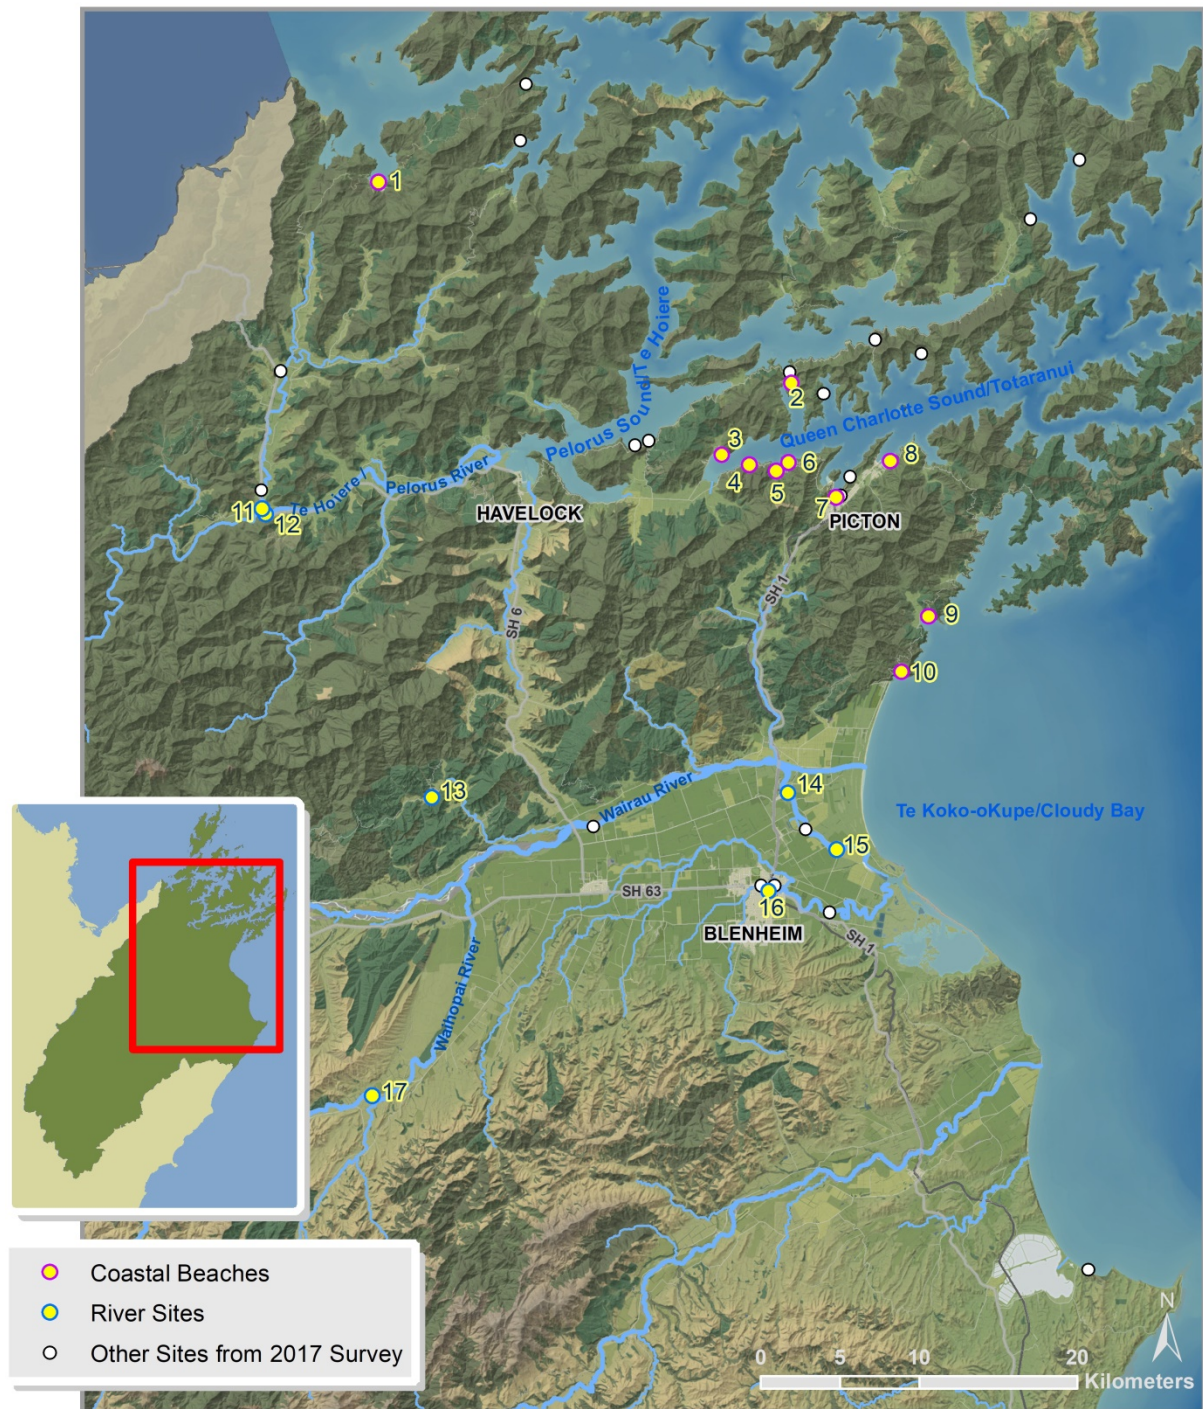
Figure 1: Monitoring Sites of the Recreational Water Quality Programme (numbered). The map also shows sites that were part of the 2017 Site Usage Survey, but are not currently monitored.

During the 2018/2019 summer season, council monitored ten coastal beaches and seven river sites (Figure 1). These sites were the most popular swimming locations in a site usage survey carried out in 2017 [5].

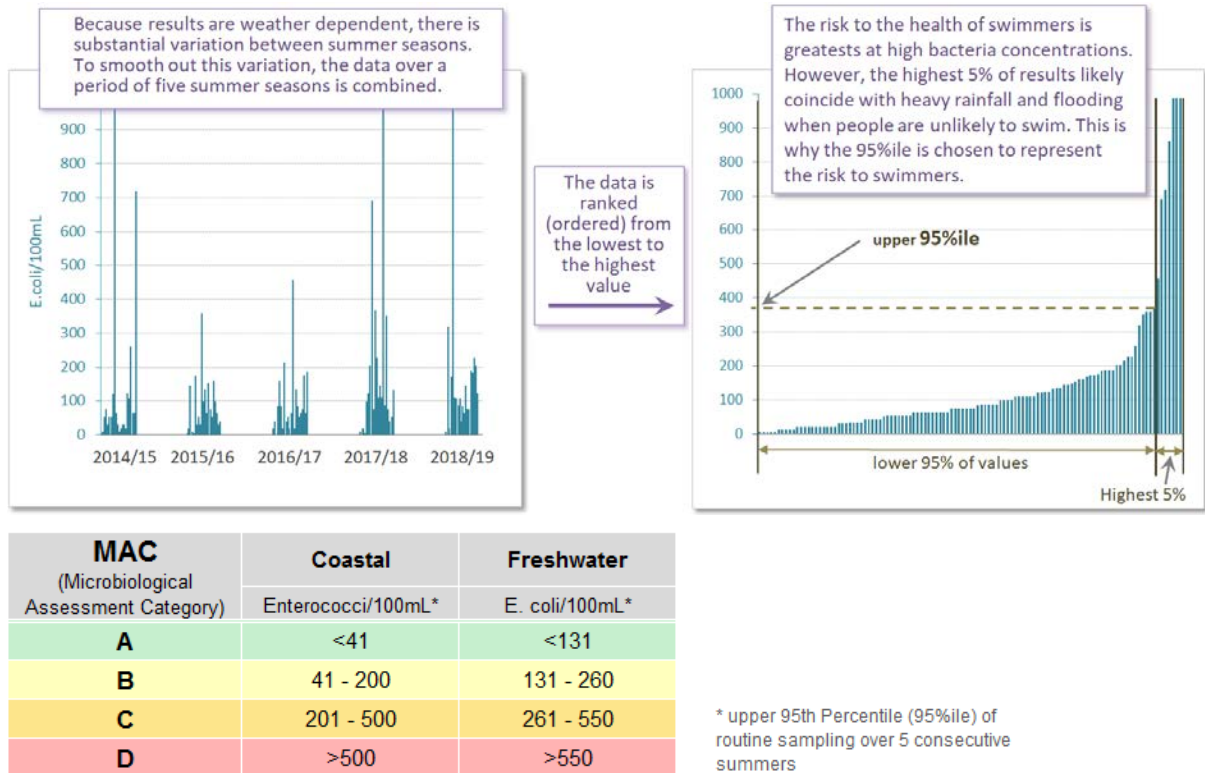
**Figure 2: Calculation of the upper 95%ile, which is used to assign the Microbiological Assessment Category (MAC) based on the table shown.**

The second part of the SFR grading is the **Microbiological Assessment Category, MAC**. The MAC is calculated from bacteria concentrations in samples taken at a site. MACs range from A to D and are based on the upper 95th percentile (95%ile) calculated with the Hazen method (Figure 2).

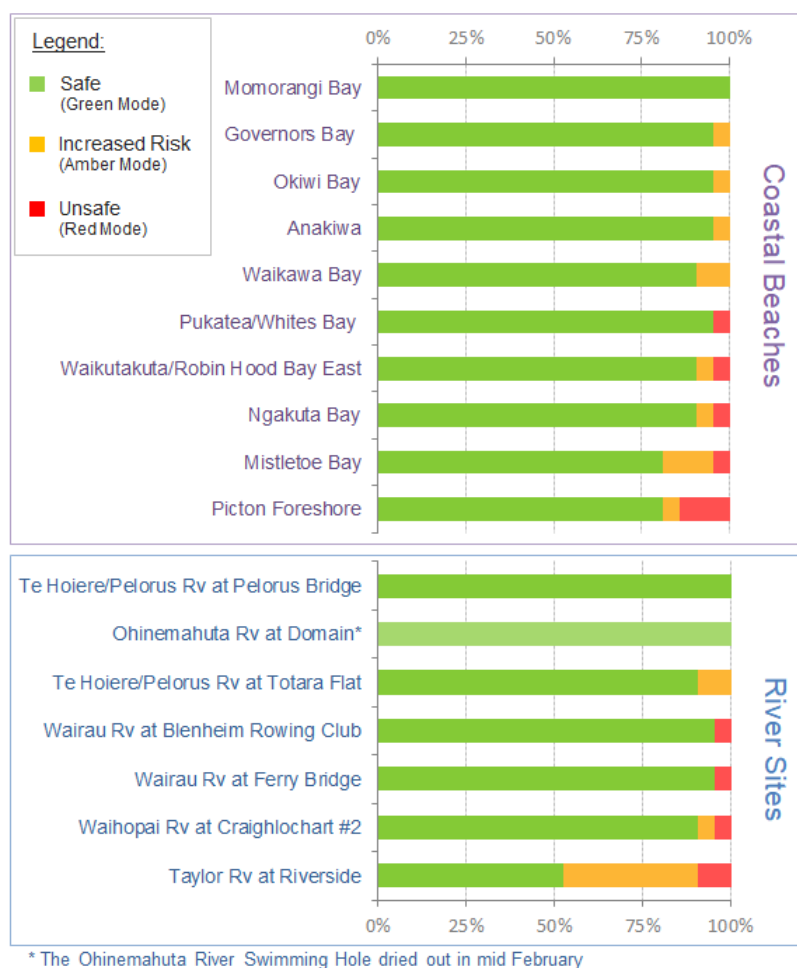
**Figure 3: Percentage of routine samples within the different Guideline modes, for all sites sampled during the 2018/2019 summer season.**

Figure 3 shows the percentage of results in the different modes set out in Section 3.1 for all routine samples taken this season.

The majority of samples had indicator bacteria concentrations at safe levels. Occasional unsafe bacteria concentrations were almost exclusively related to rainfall. Additional sampling following guideline exceedances, showed a return to safe bacteria levels within a day or two after rainfall subsided.

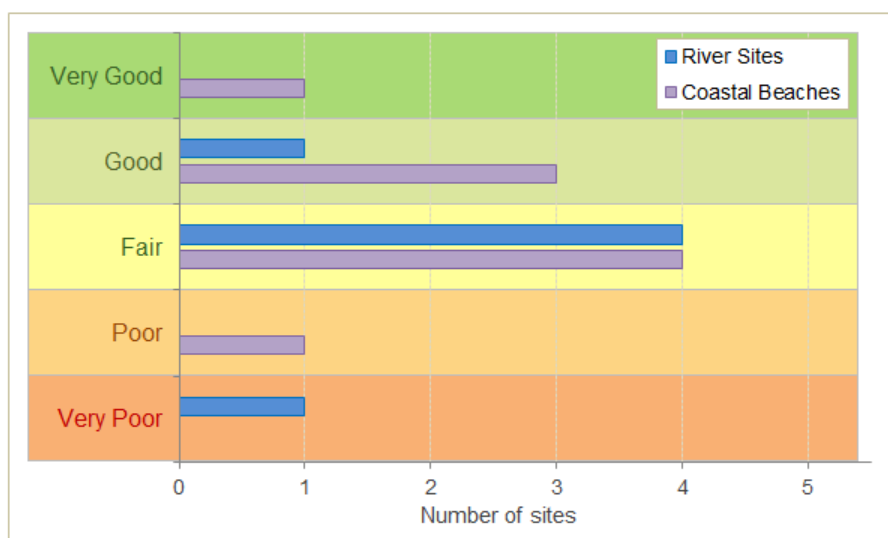
**Figure 6: Number of sites in the different SFR Grades.**

The majority of sites have a SFR Grade of 'Fair' (see Figure 6), with an equal number of coastal and river sites in this category. A grade of 'Fair' means that water quality is generally satisfactory, but swimming should be avoided following rainfall (see Section 3.2). This is consistent with our monitoring data, which show that high indicator bacteria concentrations at these sites are mostly linked to rainfall events.
