Peninsula Road Stopbank Repair & Upgrade

Spring Creek Community Meeting

5th June 2024

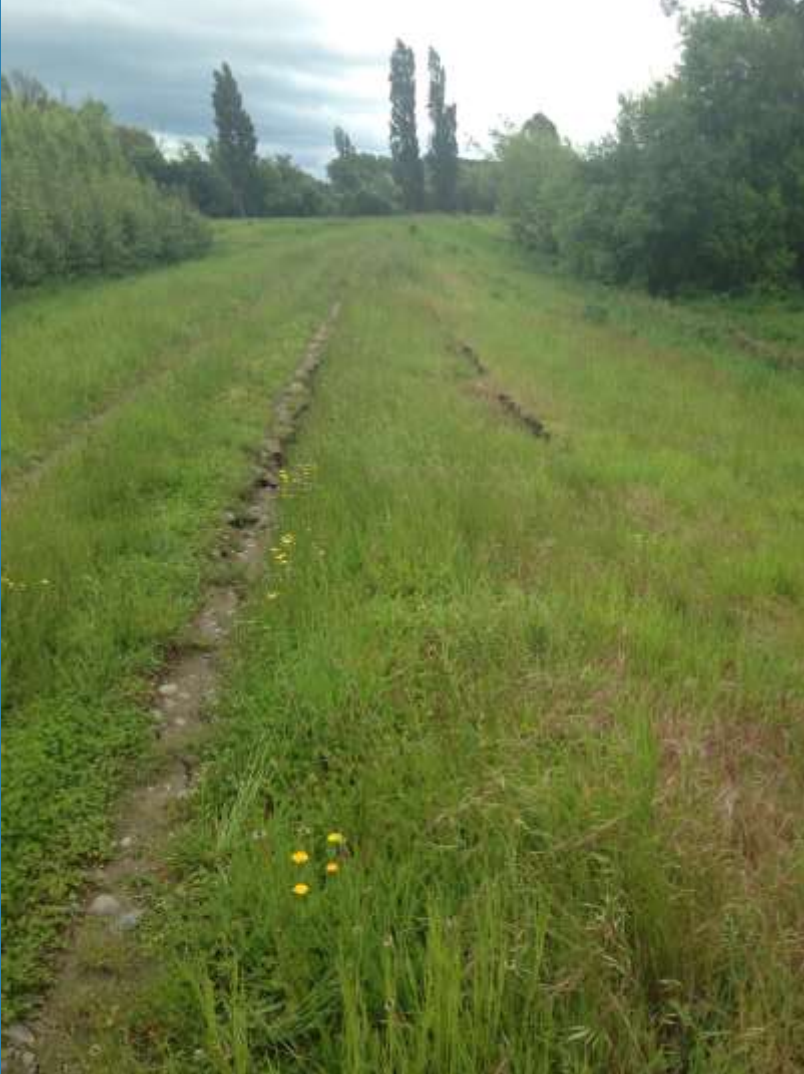
2016 Kaikōura earthquake

LW06 - Lateral Spread

7. The 2016 Kaikōura earthquake resulted in lateral spread along much of LW06, requiring the full reconstruction of a large section of bank in 2017 (Figures 1-4 below). Whilst both LW05 and LW06 were assessed post-earthquake, lateral spread was only identified along the grassed sections of bank (LW06) where surface cracking was clearly visible on the bare ground. LW05 differs from LW06, in that Peninsula Road runs along much of its length and the flexible chipseal surfacing can mask the visual identification of lateral spread.

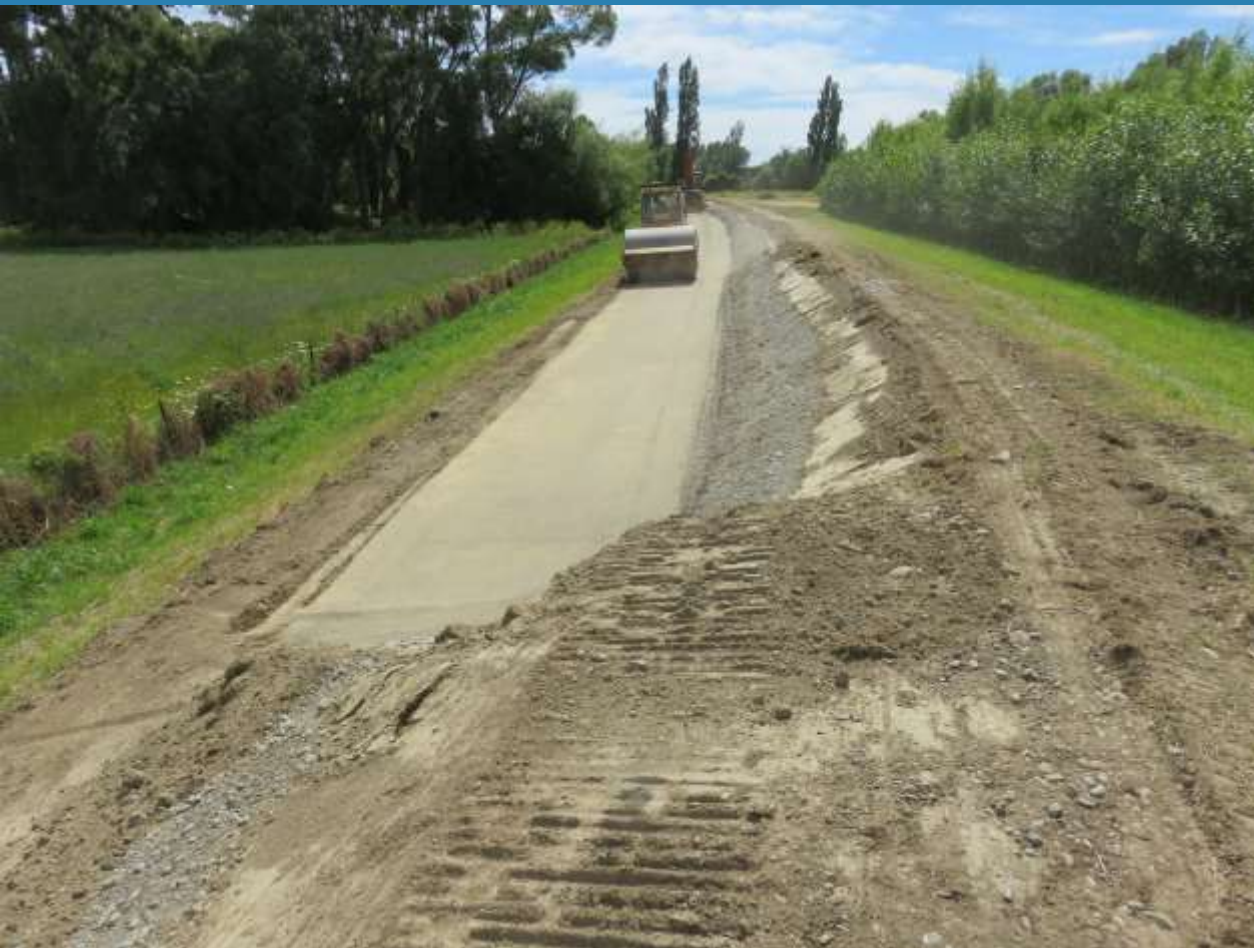
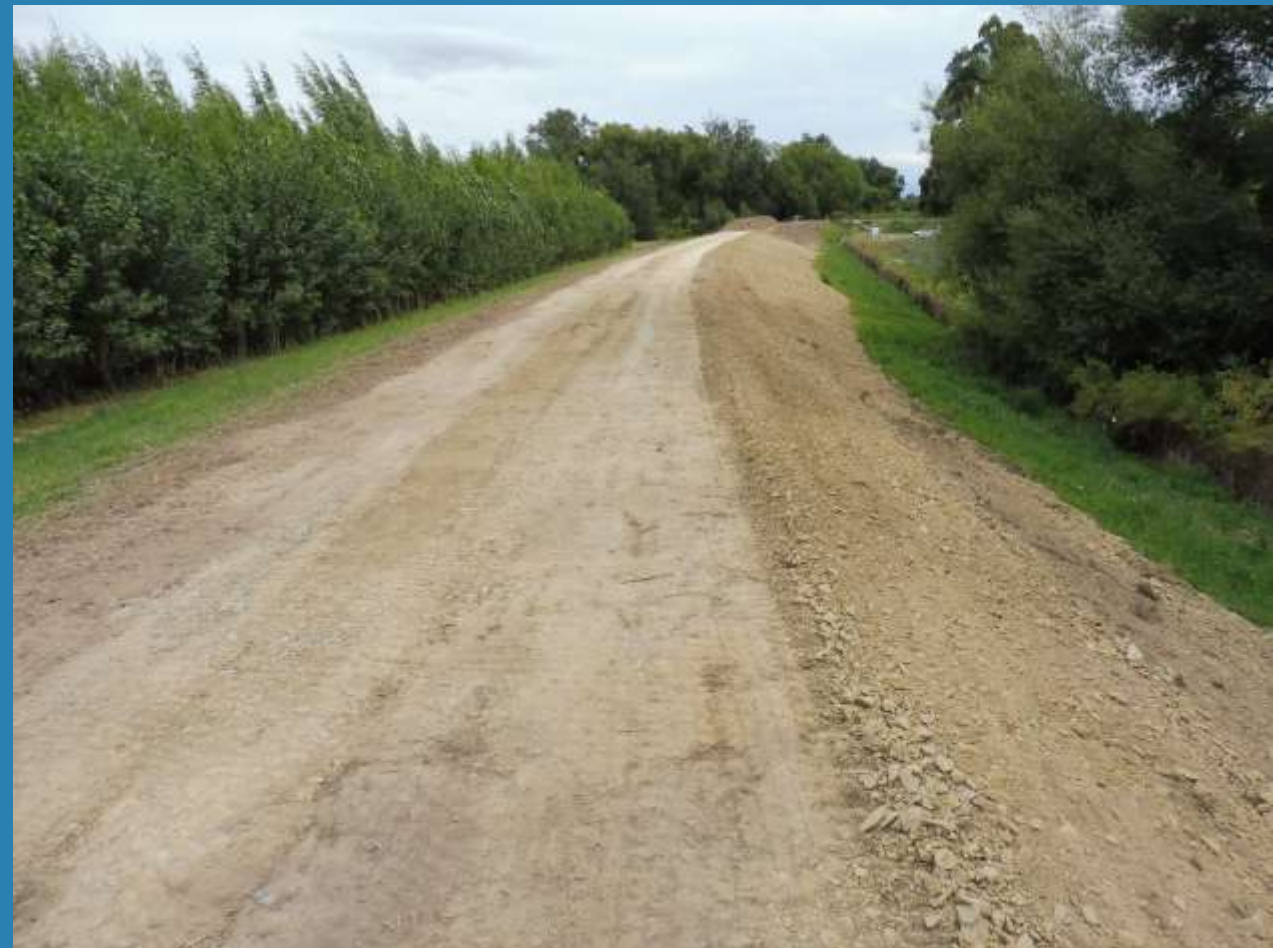
LW06 - Rebuild

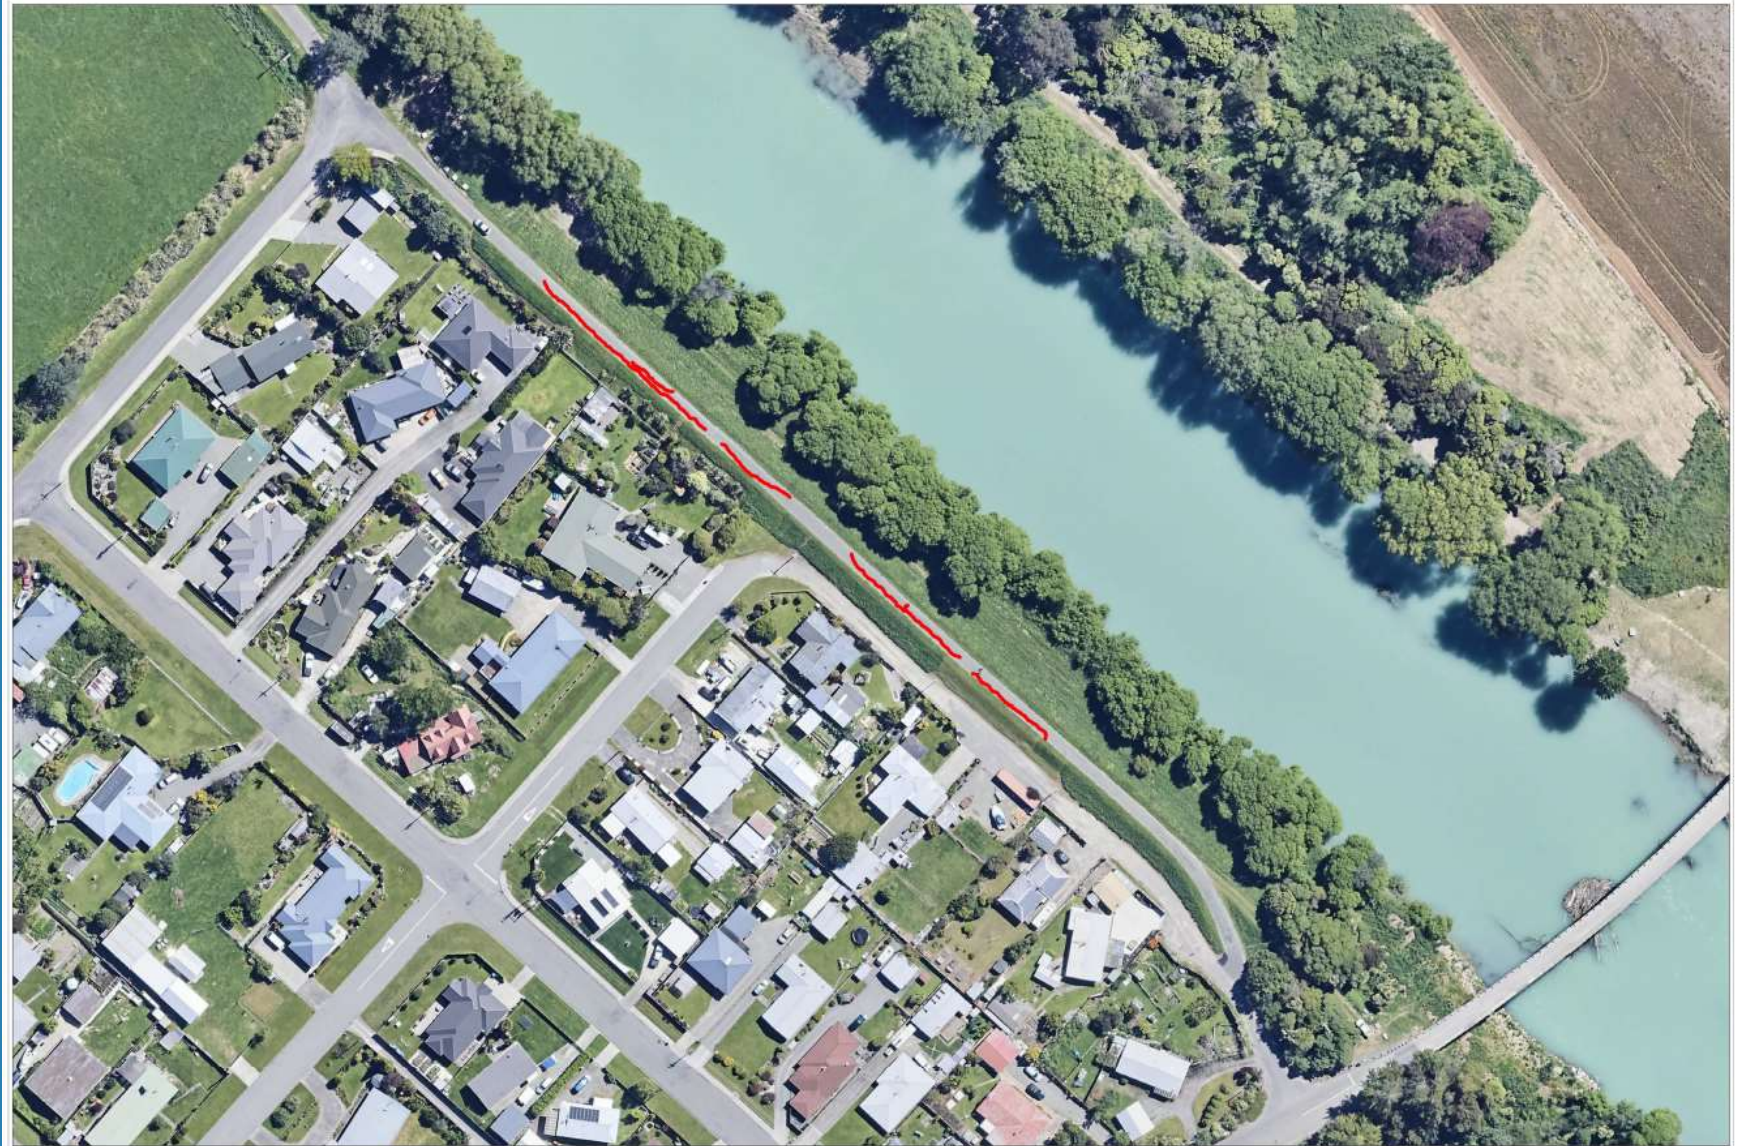
Crack Map 1

Deformation Survey

1:500

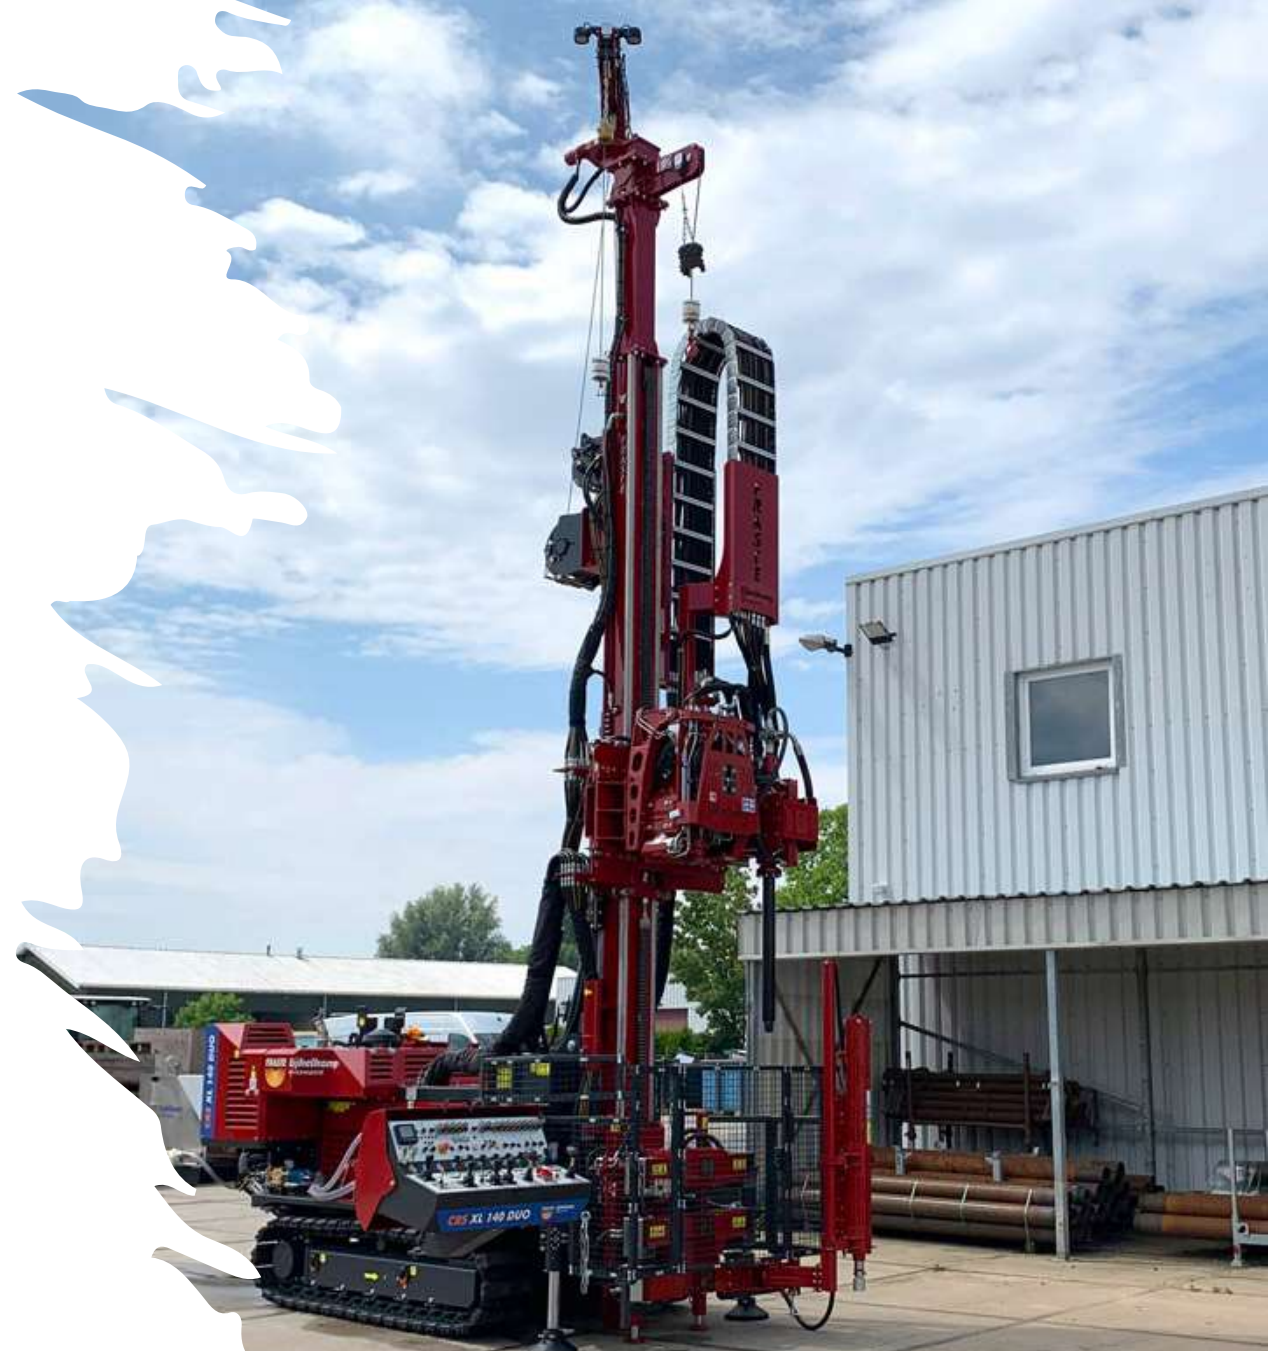
Geotechnical investigation

Commenced 20th May 2024 with:

- 13no. Boreholes (including 5no. piezometers)
- 6no. Test-pits
- 6no. Cone Penetration Tests (CPT's)

Will inform the ongoing design work, helping to ascertain the extent and cause of deformation.
