Assets & Services Committee Meeting

“A Marlborough Review of the Report of the
Hawke’s Bay Independent Flood Review”

Report of the Hawke's Bay Independent Flood Review

July 2024

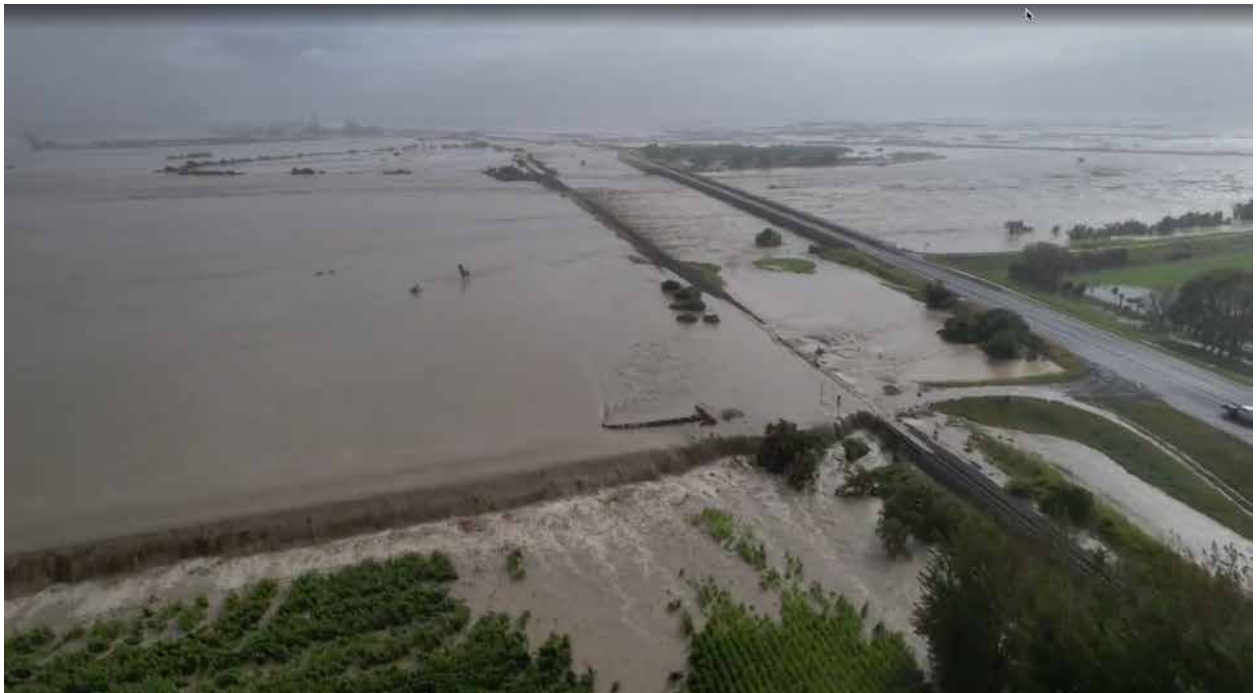
Figure 2.2 Tutaekuri and Ngaruroro River mouths, 14 February 2023¹²

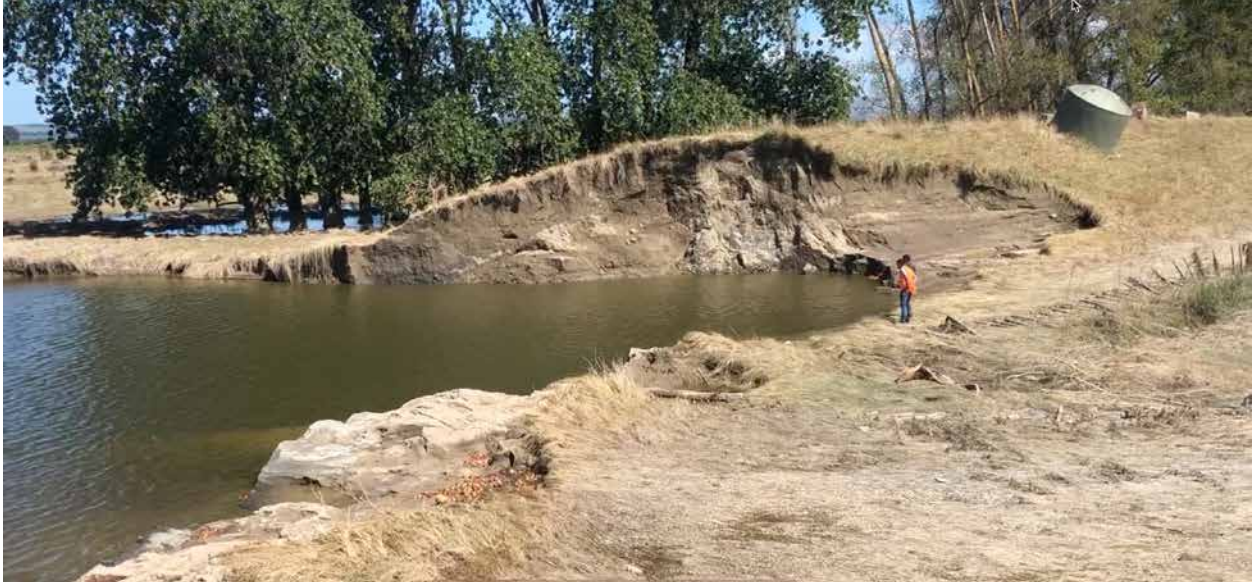
Figure 2.8 Ngaruroro Stopbank Breach Pakowhai³²

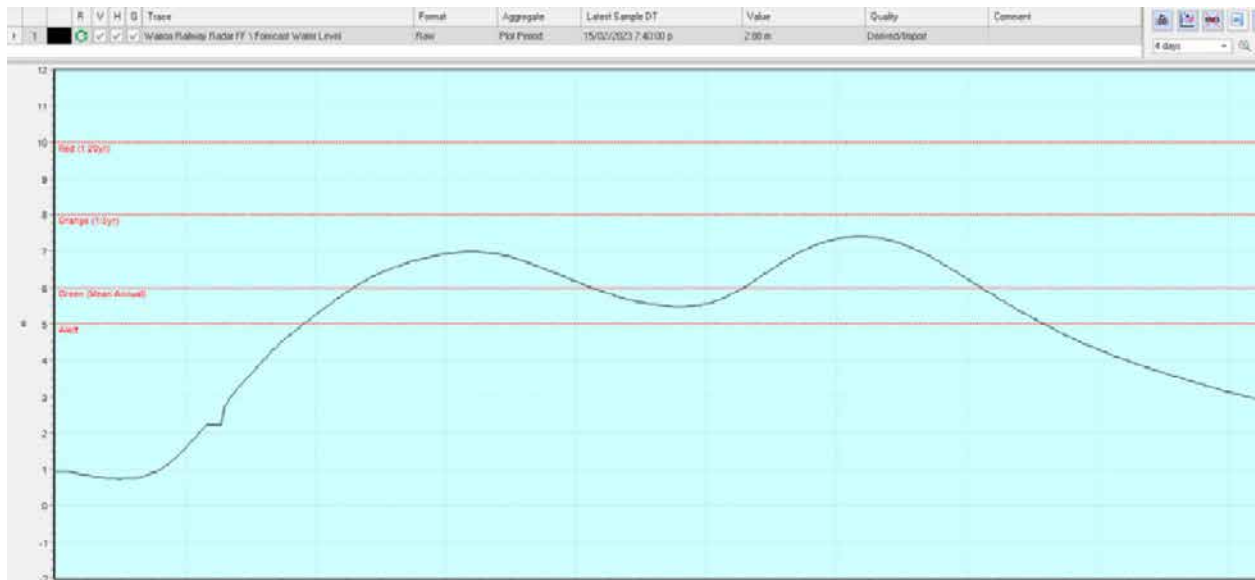
Figure 8.1 Flood forecast for Wairoa River¹²⁹

A further update to the forecast was issued at 11:30pm, predicting a slightly smaller event of somewhere between a two-year and five-year flood event, with a peak level on Tuesday morning just above the “GREEN” warning level (see Figure 8.1).

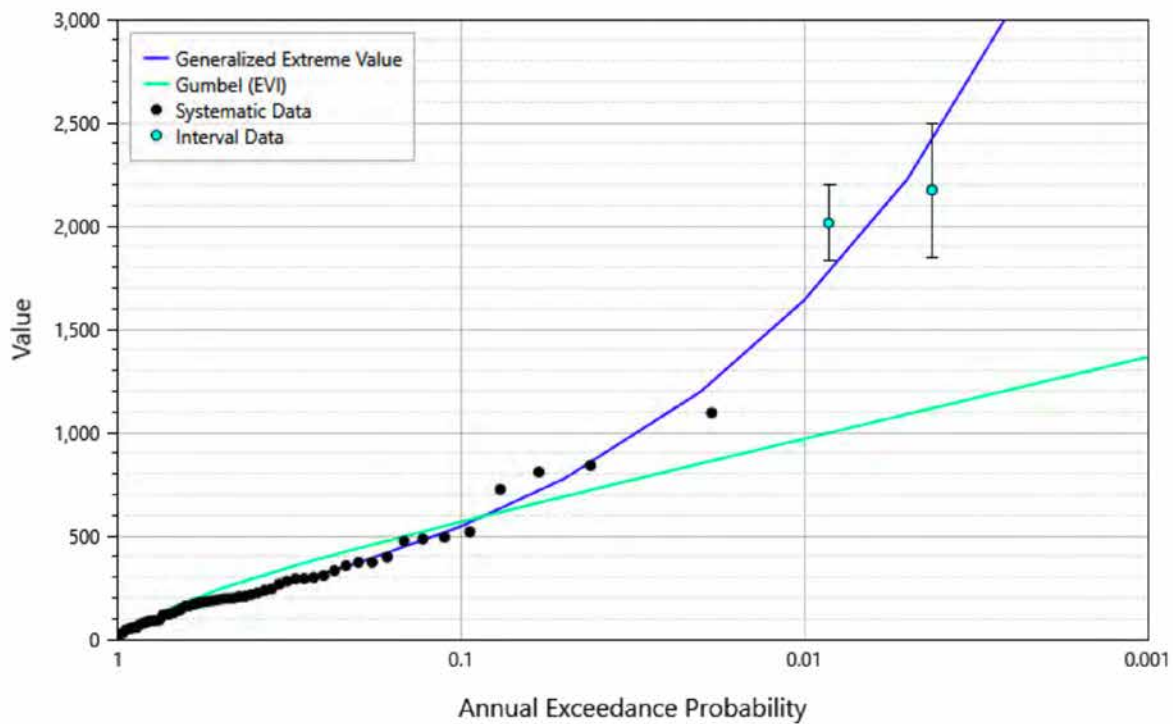
Figure 8.3 Esk at Waipunga Bridge flood frequency analysis¹⁴⁵

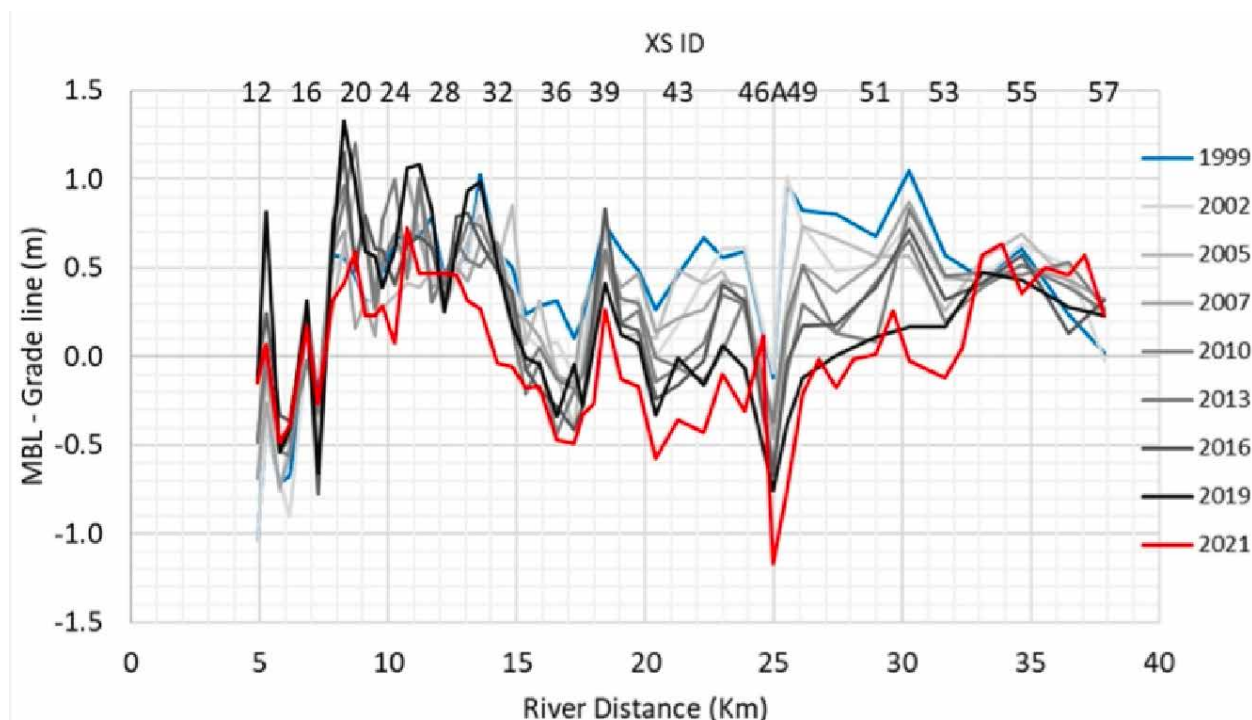
Figure 8.8 Ngaruroro riverbed levels¹⁷⁵

the flooding that occurred. This was not the case for the Ngaruroro River, where gravel extraction of approximately 300,000 m³/year greatly exceeded the average historical natural gravel supply rate of 120,000 m³/year.¹⁷⁴ This has resulted in the riverbed level being lower than the 1999 baseline by up to 1 m in some places (see Figure 8.8).

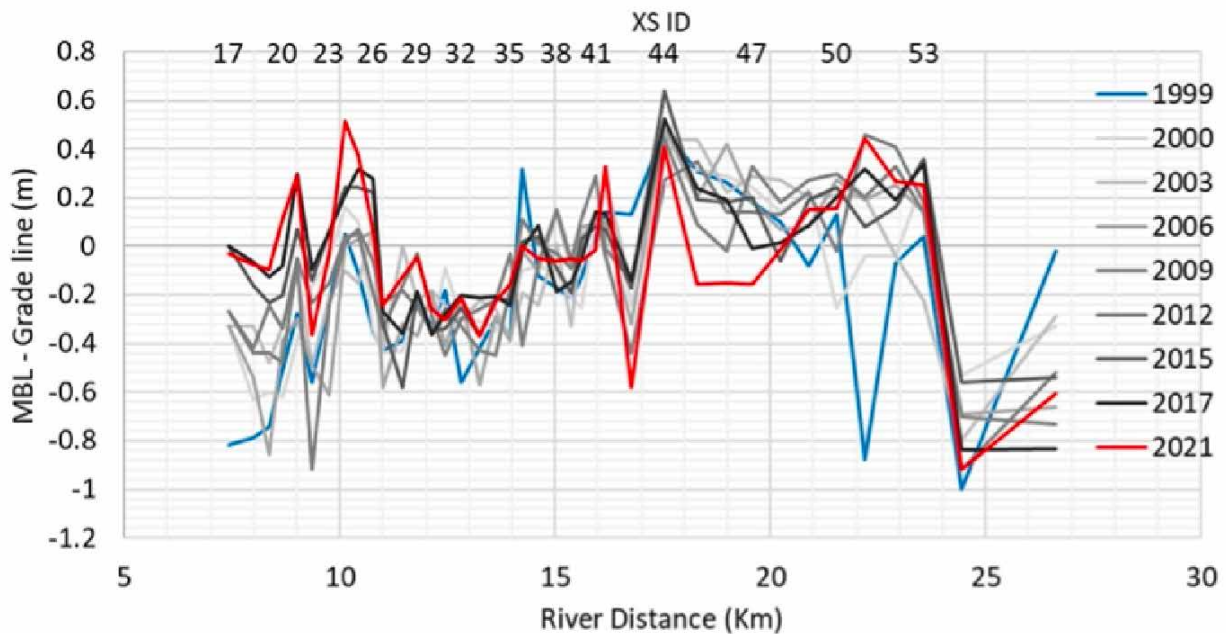
Figure 8.9 Tutaekuri riverbed levels¹⁷⁶

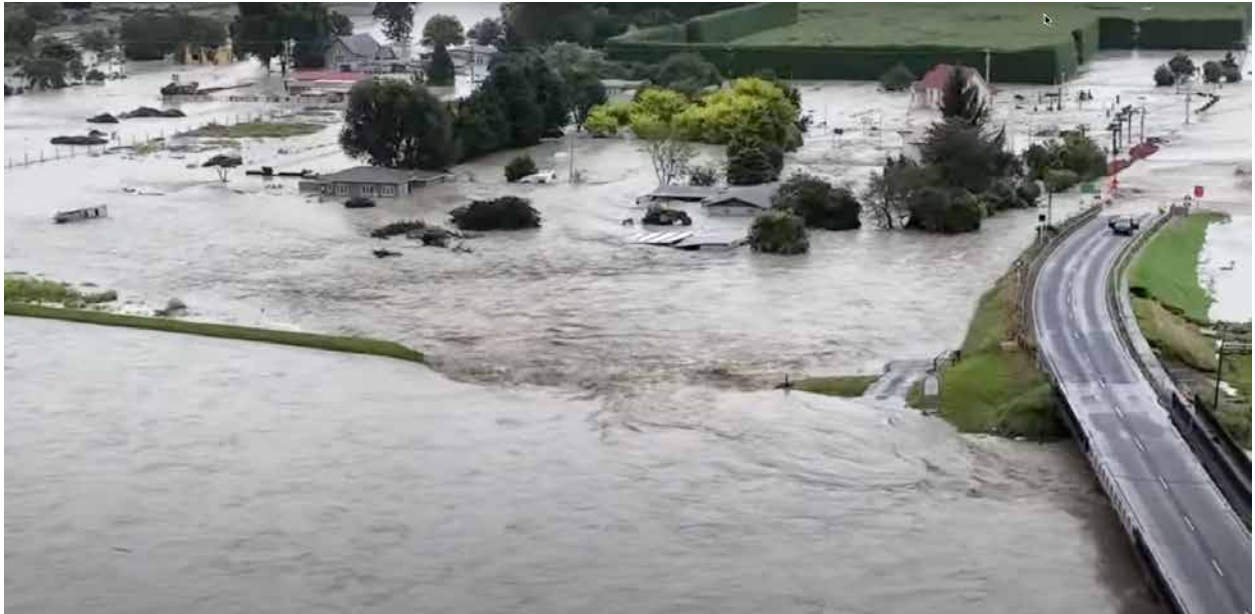
Figure 8.10 Ngaruroro River breach at Omahu¹⁸⁴

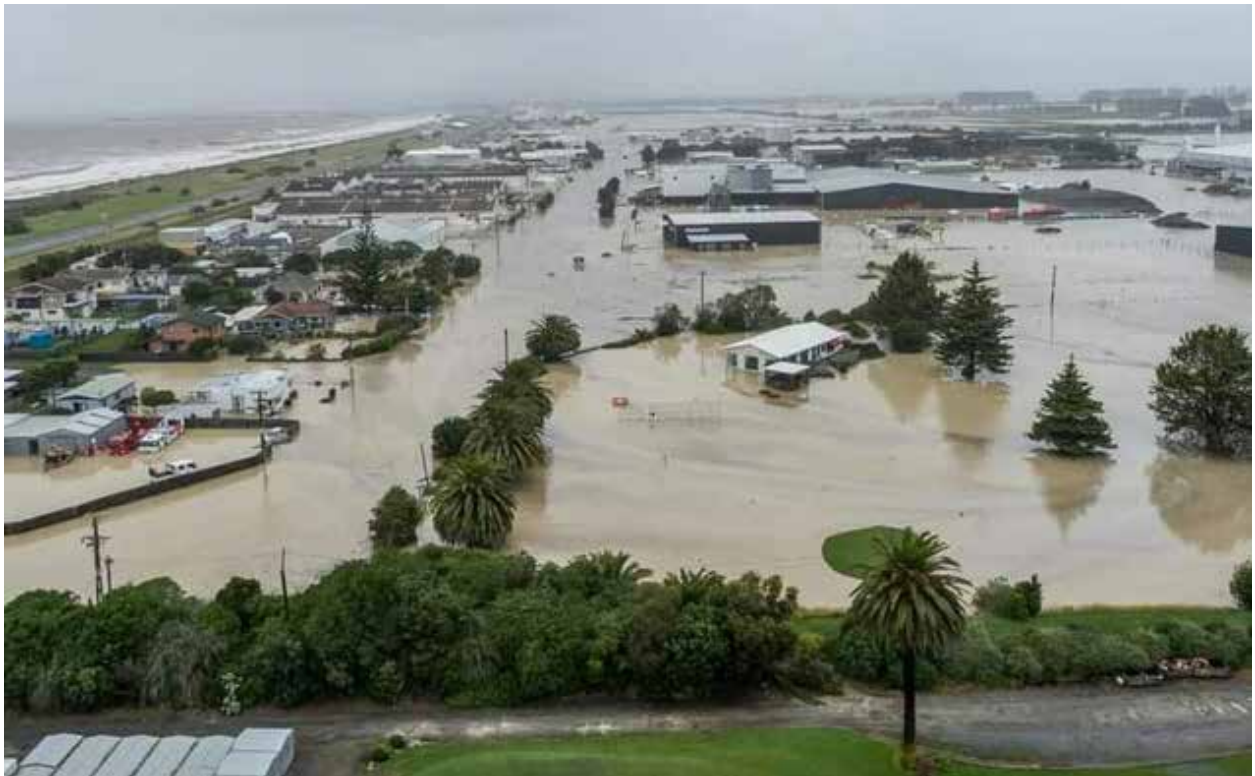
Figure 8.11 Breach at Awatoto¹⁸⁵

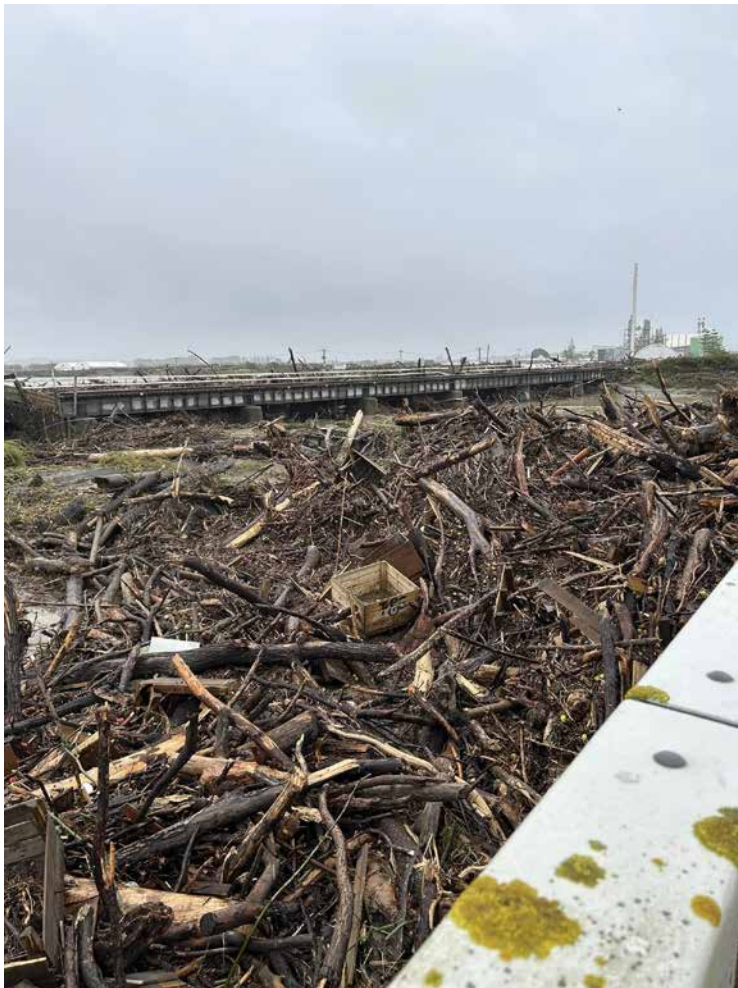
Figure 8.12 Debris at Waitangi Railway Bridge and road bridges immediately downstream of Awatoto stopbank breach¹⁸⁷

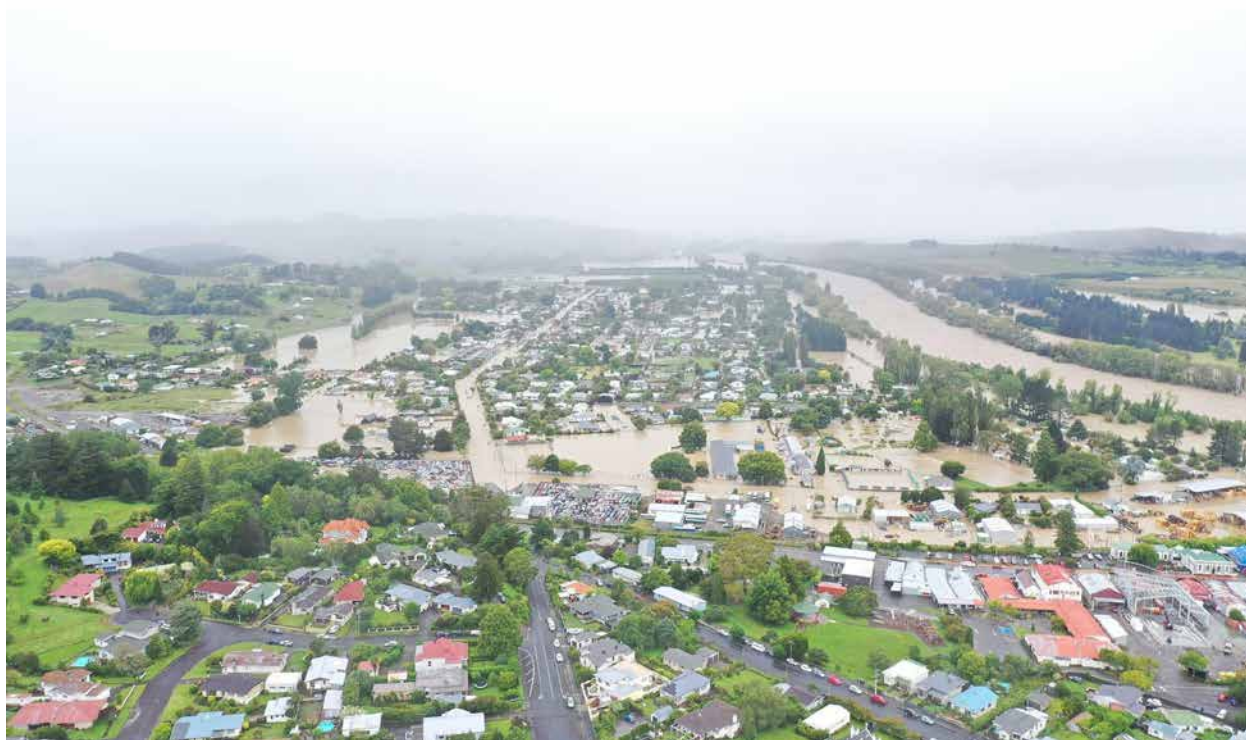
Figure 8.13 Waipawa flooding due to stopbank breach¹⁹²

The Waipawa River had an estimated flood flow of 1,800 m³/s during Cyclone Gabrielle, which, based on NIWA's assessment of systematic flow records back to 1987, suggested a recurrence interval in excess of 1,000 years. This flood exceeded the capacity of the system and overtopped stopbanks on the left bank upstream of Waipawa township, causing widespread flooding in residential and commercial premises (see Figure 8.13). It is noted that floodwater originating from Bush Drain in the northern areas of Waipawa also contributed to the inundation of properties.

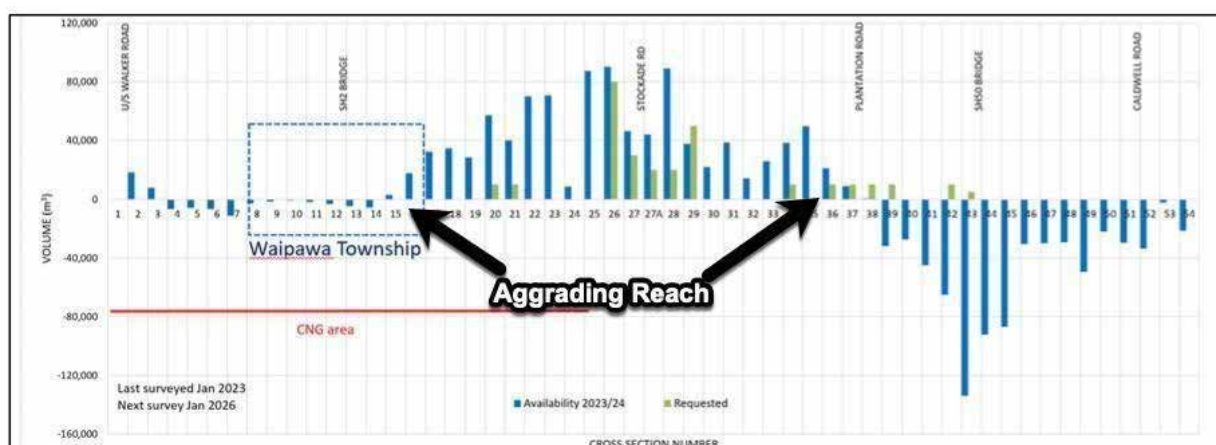
Figure 8.15 Long section of gravel volume above design grade for the Waipawa River¹⁹⁸

In HBRC's response it highlighted that the reach of the river where most of the aggradation has occurred is upstream (see Appendix E, Figure E7) of where the stopbanks breached in Waipawa and at Walker Road (see Figure 8.15).

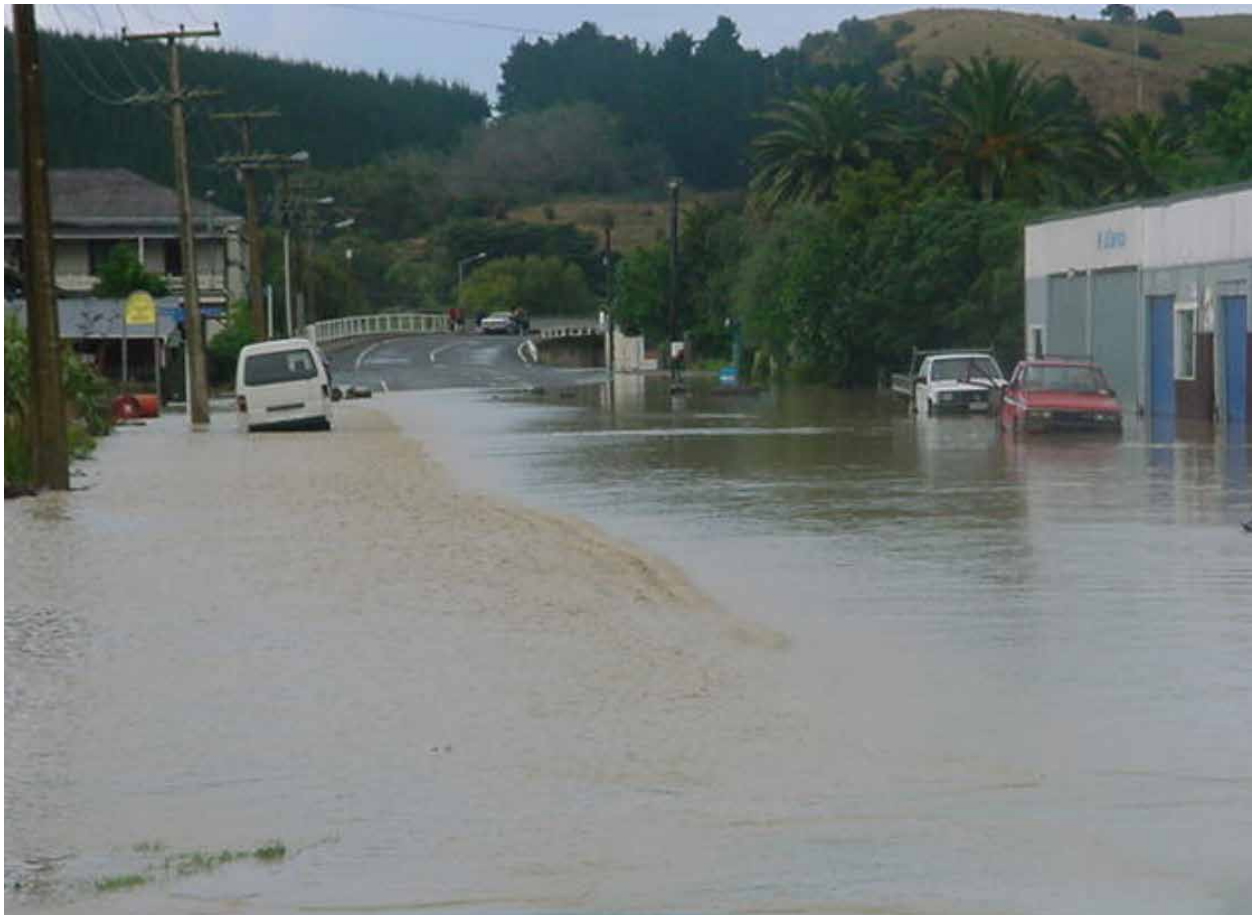
Figure 8.17 Pōrangahau during 2004 flood²¹⁰

In 2004, there was a notable flood (see Figure 8.17), with river levels rising 10 metres and an estimated discharge of 550 m³/s. This resulted in flooding through the town (see Appendix D, Figure D16), probably to a lesser extent than that of the 1941 and 1953 floods.

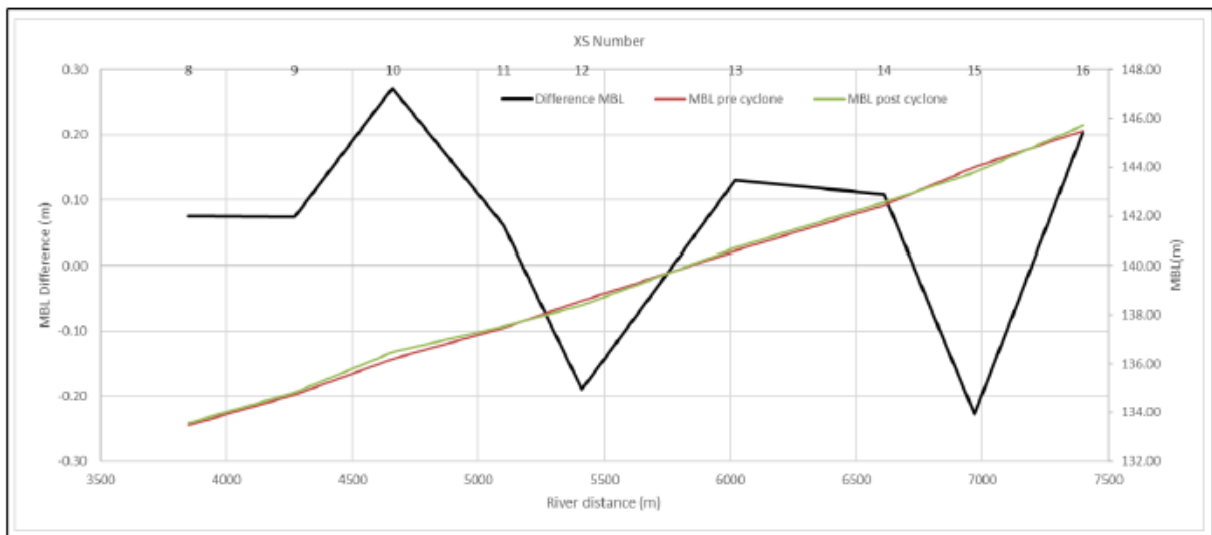
Figure 6.4 – Waipawa River - Mean Bed Level (MBL) at Waipawa; Comparison and Difference pre-cyclone vs post cyclone

It should also be noted, as was mentioned above, that any areas of gravel aggradation are many kilometres from the Waipawa township, where overtopping of stopbanks occurred. The width of Waipawa river diminishes significantly, from an average width of 160 m to around 100 m, just downstream of the township. This is more likely to have been a factor in containment of flood flows.

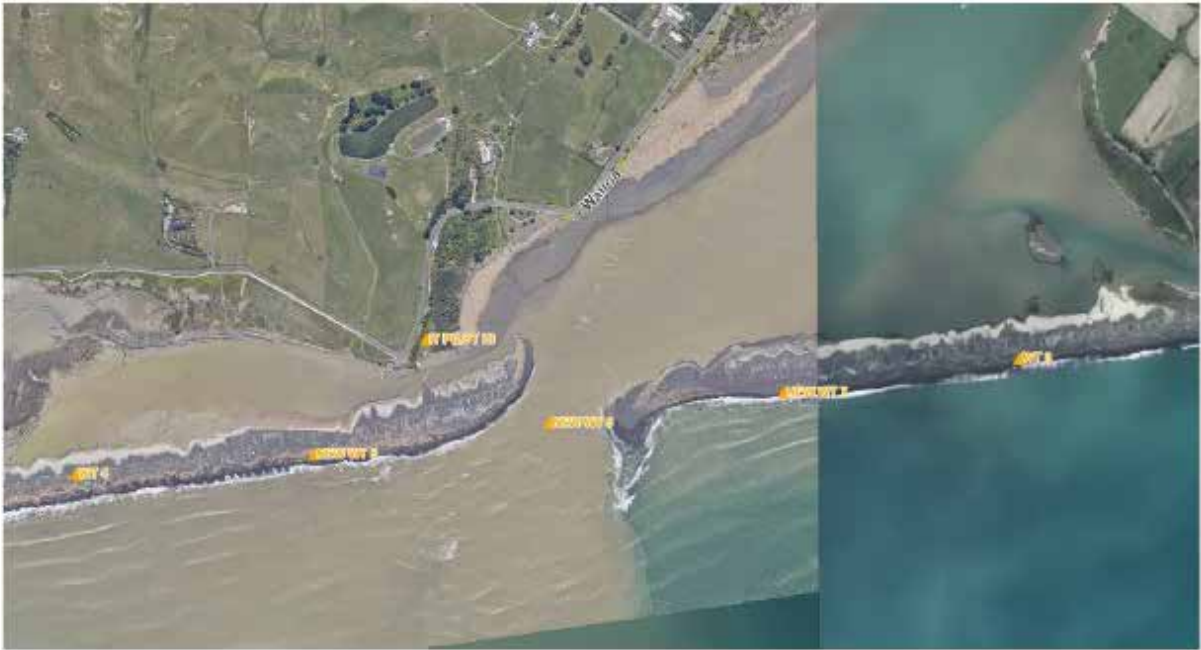
Figure 12.1 – Wairoa River Mouth – 16 February 2023

It is also worth noting that during high intensity flooding events, flood conditions rapidly scour out river mouths for effective discharge. This was seen at the Wairoa River mouth and the Ngaruroro, Tutaekuri and Clive River mouths – particularly where the Tutaekuri created a new river mouth. Figures 12.1 and 12.2 below show those river mouths in the immediate aftermath of Cyclone Gabrielle.

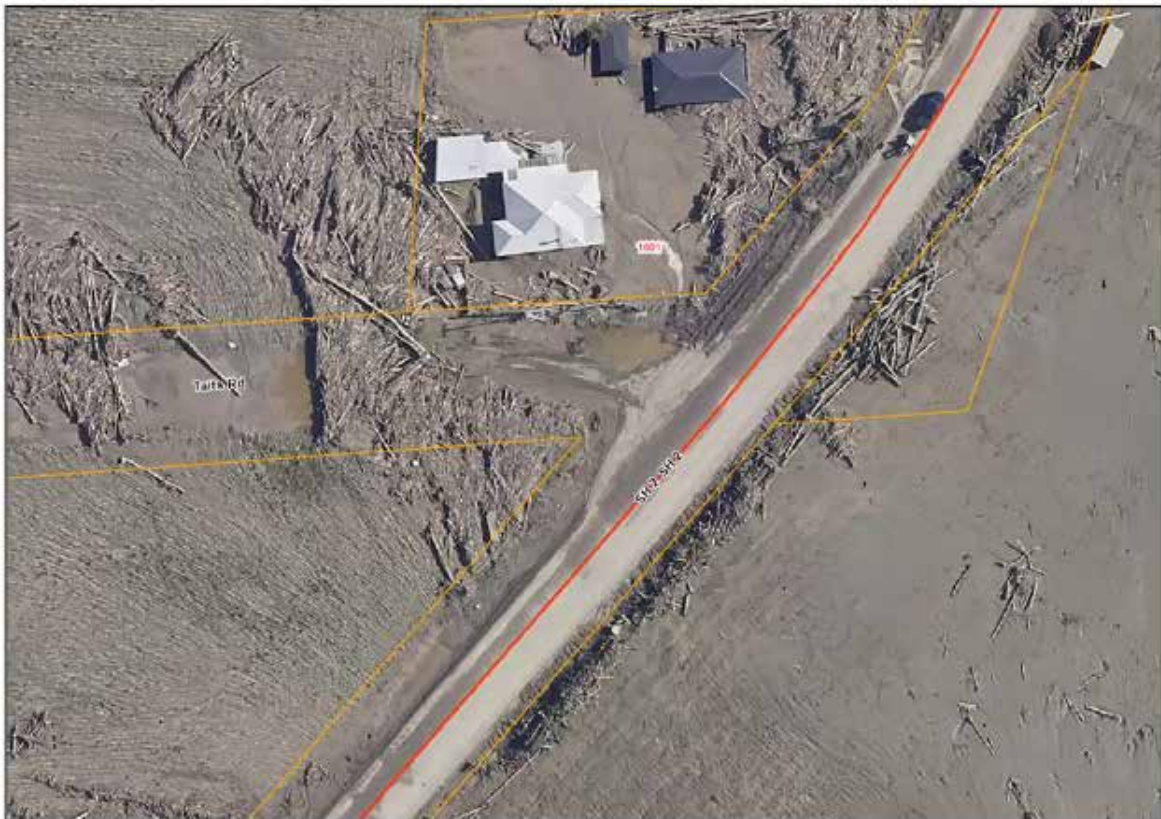
Figure 13.1 - Woody Debris build-up near Esk River mouth.

Storm surge at least 0.6 m during the event was significant, and gravel movement which blocks the mouth is a constant issue that cannot be overcome within the budgets that would be expected for such a catchment. There is consented concrete dump site near the river mouth on private land that would likely influence or prevent a permanent wide opening to cater for the amount of debris during the event.

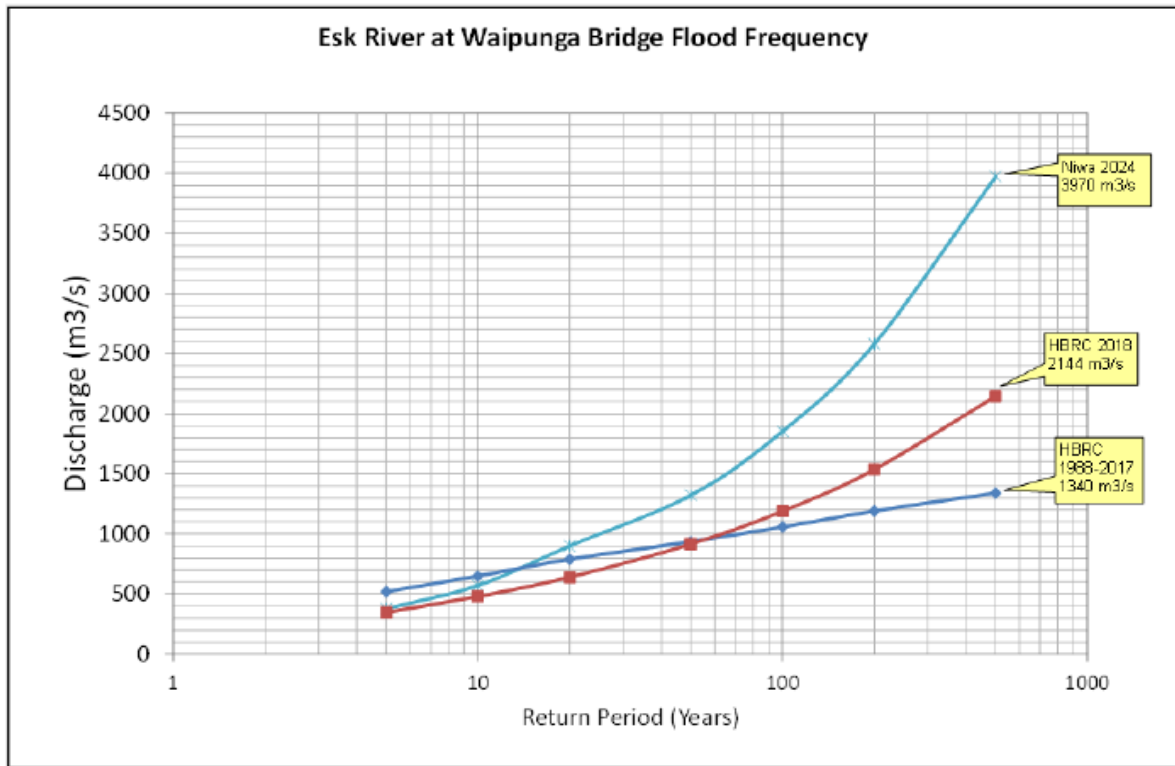
Figure 21.1 - Comparison of flood frequency curves

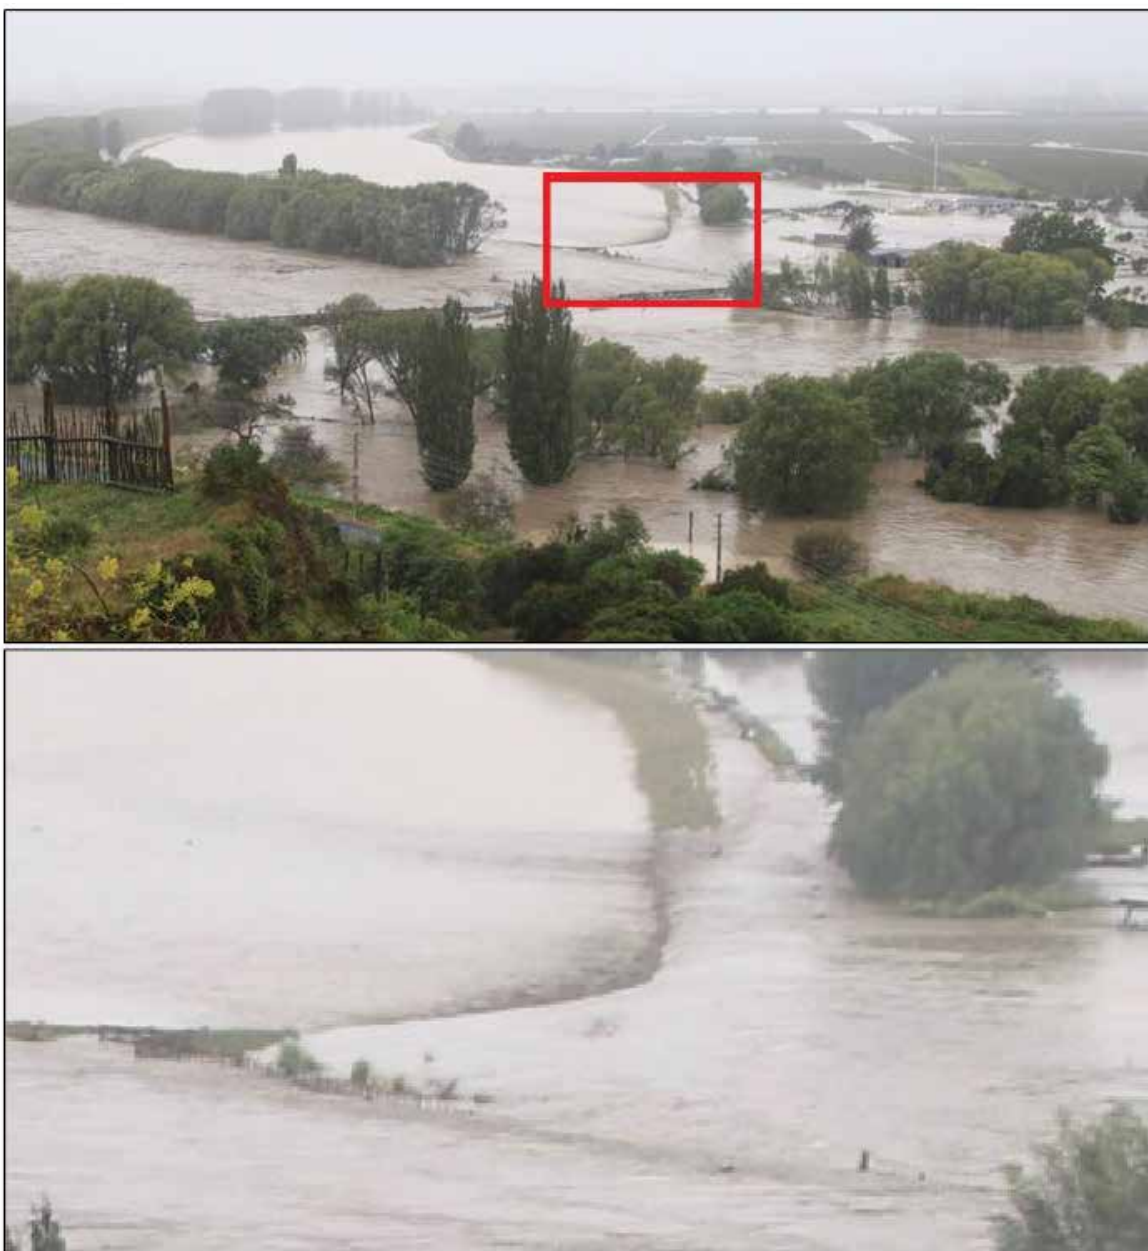
Figure 40.3 – Photos showing water flowing back into the Tutaekuri river at the approximate location of the designated breach site

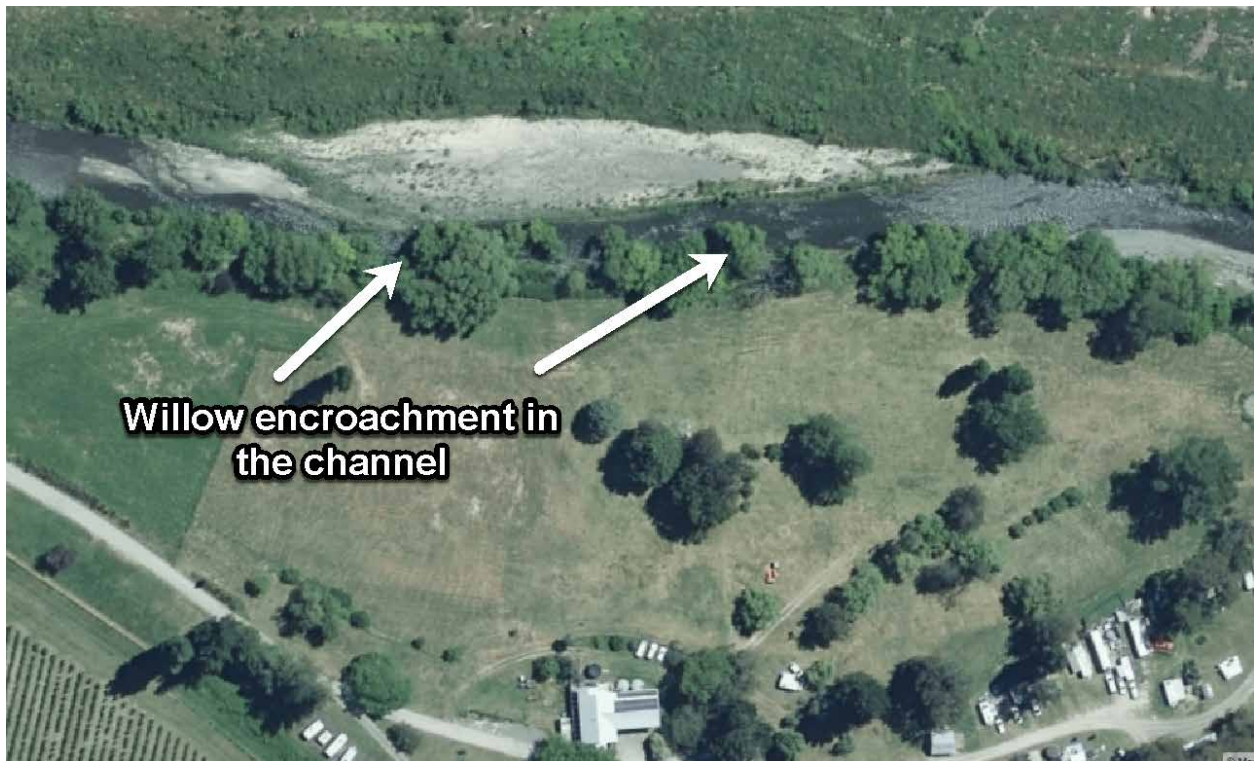
Figure E3 Willow Encroachment into Esk River

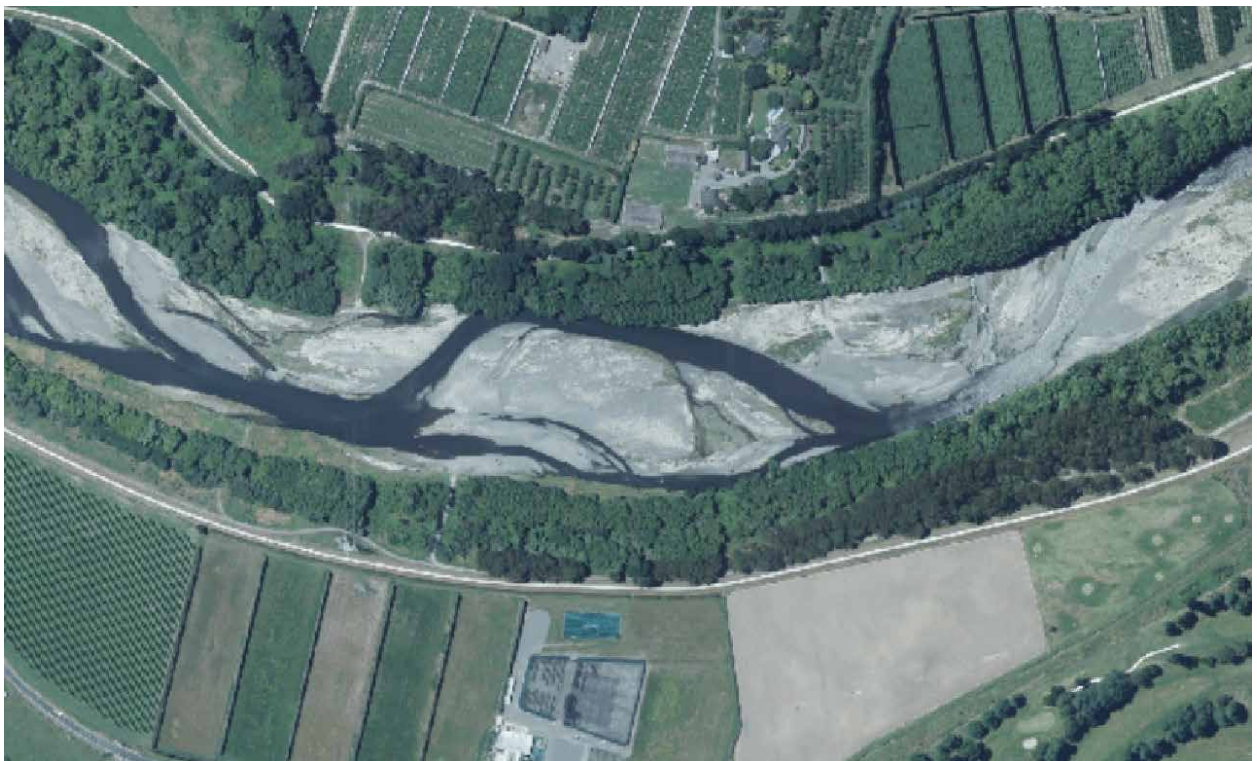
Figure E4 Tutaekuri River Buffers and Channel Pre-Cyclone

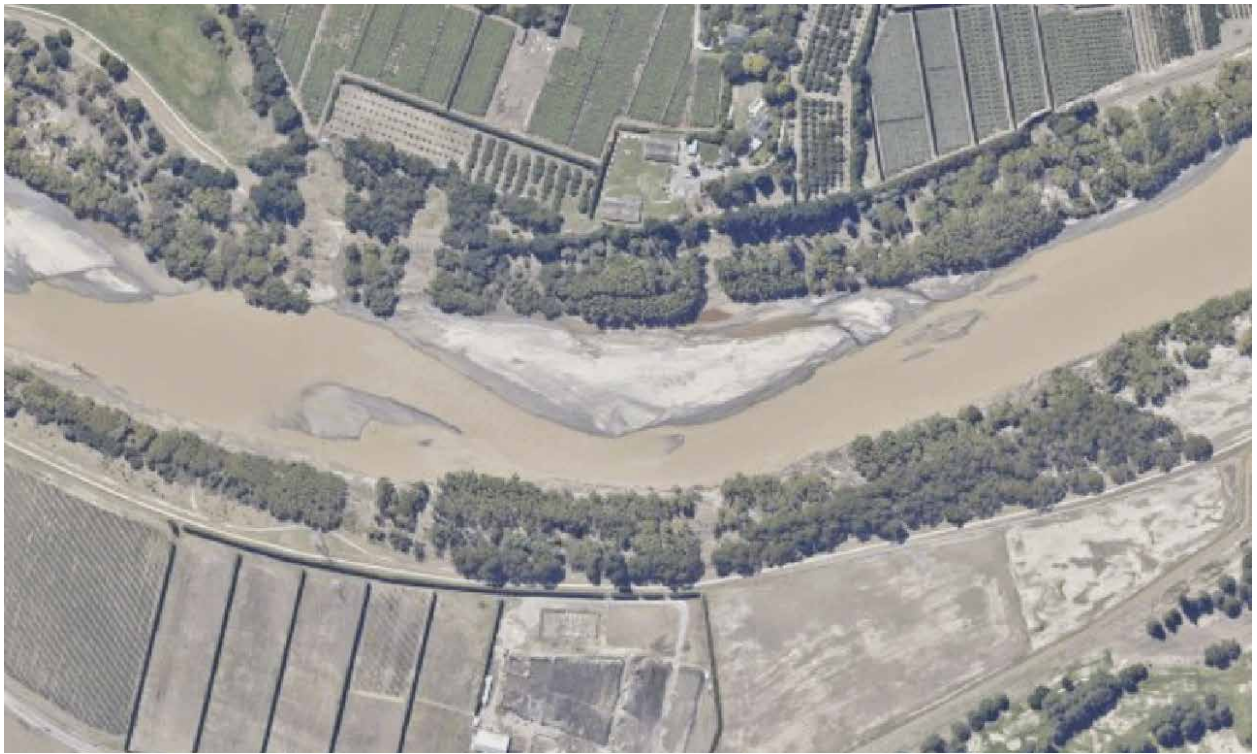
Figure E5 Tutaekuri River Buffers and Channel Post-Cyclone

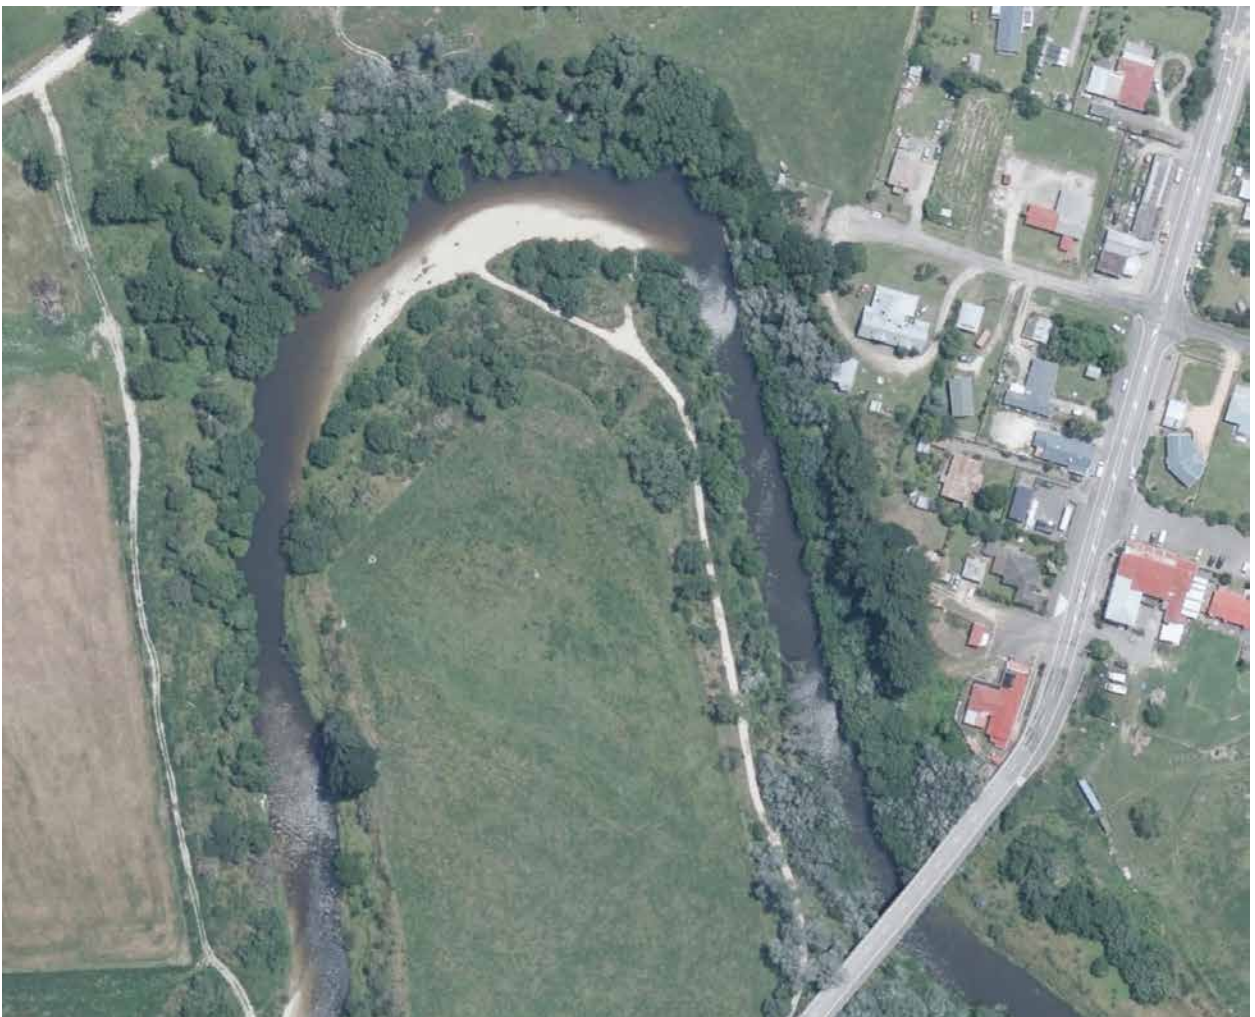
Figure E10 Pōrangahau River Channel Condition Prior to Event
